**Flood Control Project Maintenance
Levee Inspections**

Maintenance Issue Types Only, Levee Inspection Report By Mile - Fall 2018

Sacramento Maintenance Yard Putah Creek

Waterway	Bank	Unit Miles	Inspection Start/End	Inspector
Unit No. 01 Putah Creek or North Levee	Left	8.79	09/27/2018 09/27/2018	David Julian

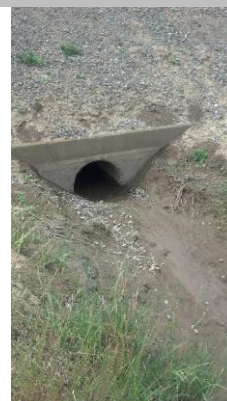
Photo 1 of 3 : UCIP_FA_2018_33371_60418.jpg

LM Start	5.28	Rating **	A/W	Issue No.	64	
LM End	5.28	Issue Type +	Ma	Location *		
Category	Supplemental			GPS Latitude/Longitude		
				Start	End	
Item	DWR UCIP LMA Responsibility			38.518022 °	38.518022 °	
				-121.722521 °	-121.722521 °	
DWR ID	500					
Comment Code						
Inspector Comment						
FS_ID:33371 DS_ID:500 EP_NO: 10256 Repair Type: No Action Needed Crossing Status: Found UCIP Comments: Debris removed. See picture FIELD_STRUCT_DESC: 24-inch corrugated metal drainage pipe through the levee, 15 feet below the crown. Slide gate on the waterside (WS) end. Concrete headwall on the landside (LS) end. (24-inch pipe [HLM 5.39] authorized under Automatic Board Order (ABO) issued as Permit No. 10256, 1974 - Albert H. Lederer). [Additional Reference(s): DWR Levee Log, 2005. USACE Sacramento O&M Manual 119, December 1952, (Station 83+70 PCT)]. FS Date: 4/10/2014 2:37:39 PM
